⑥ National Dam Inspection Program
TOWAMENSING TRAILS DAM

(NDI NO. ^{number} PA-00920
DER NO. ^{number} 13-108)

CARBON COUNTY, PENNSYLVANIA.

PHASE I INSPECTION REPORT.

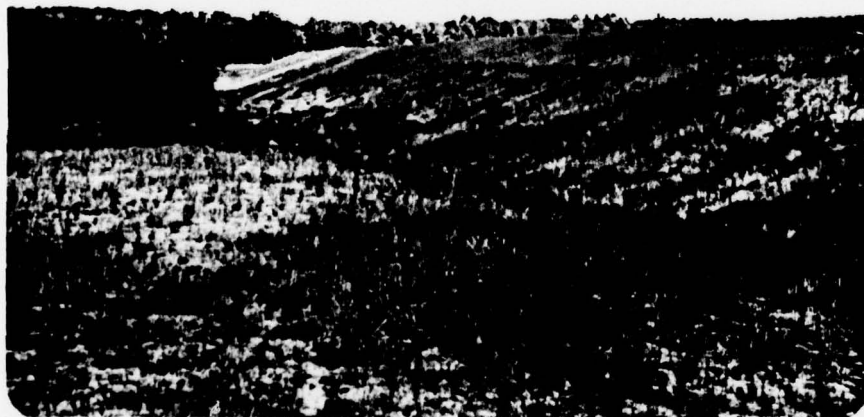
Downstream Slope

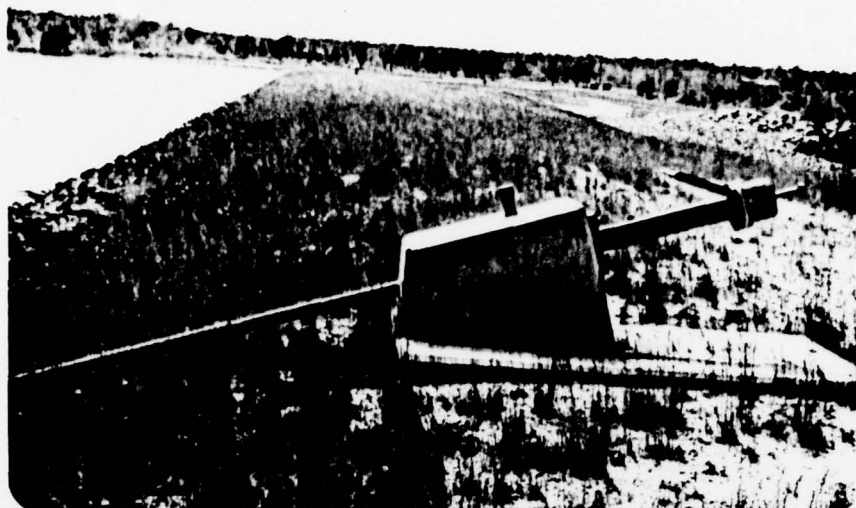
The control of the outlet control gate is in very good condition and was operated with ease at the time of this inspection.

Upstream Valve
Control on
Top of Dam.
Spillway in
Background.

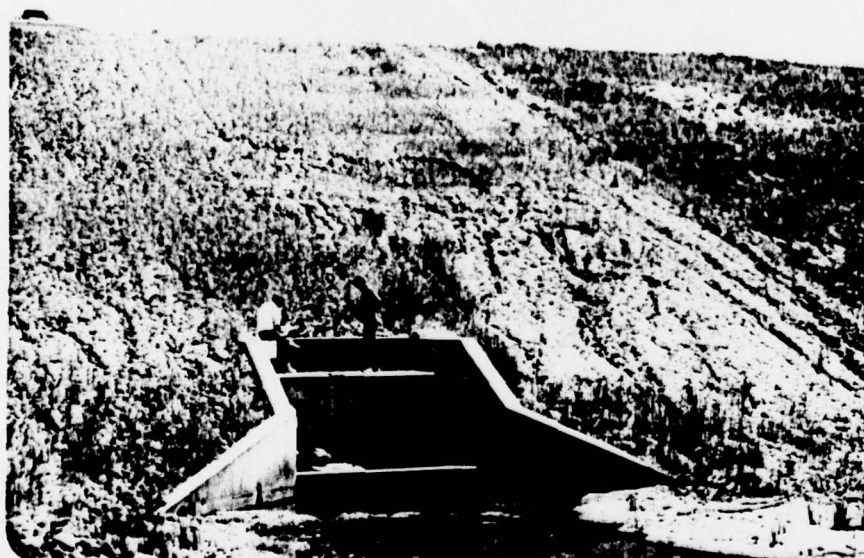
The outlet to the 36-inch pipe is a concrete energy dissipator with a concrete baffle. It is also in good condition.

Conduit Outlet
and
Slope Erosion

1. That the erosion scars on the downstream slope be repaired and that steps be taken to improve the slope cover to protect against future erosion of the slope.
2. That the seepage condition downstream from the toe of the embankment be monitored on a regular basis noting and recording volume and clarity. If increase in volume or any turbidity is observed, take immediate steps to identify the source and correct the condition.
3. That the crest of the dam be brought to the design elevation over its entire length.
4. That hole behind the left spillway outlet channel wall be filled.

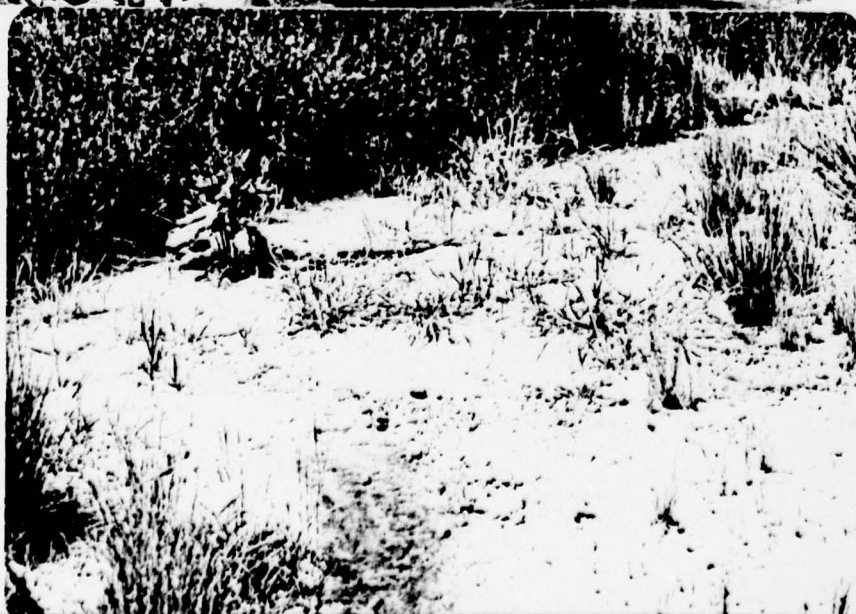
One such bubbling seepage was noted about 50 feet downstream from the toe of the embankment just to the left of the outlet channel. This water was constantly bubbling from the ground creating small mounds of sandy soil at each seepage point. The source points moved at random within a small 4 to 6 foot area during this observation. The water was clean and cold. Because of the number of seepage points, it was not possible to estimate the total flow.

The origin of the seepage condition downstream from the toe of the embankment is uncertain. The geologic report in Appendix D points out the permeable nature of the foundation materials at this site noting that there is opportunity for seepage through the soil overburden as well as through the bedrock. Also that the pressures of the artesian system in the area are in all probability increased due to the added head generated by the reservoir. The seepage points should be located in detail and should be monitored on a regular basis noting and recording flow and clarity. If significant changes are detected, immediate steps should be taken to correct the condition.

Springs are reported to exist now just below the toe of the dam. It is not certain if these seeps pre-date the construction of the dam, or if they are new. Even if they pre-date the dam construction they present a possible channel for leakage. The reservoir now represents increased head on both the artesian system in the upper bedrock and on the permeable zones in the overburden. It is my opinion that these springs be carefully monitored for changes in flow, and/or sediment load.

Springs Downstream
from
Toe of Dam

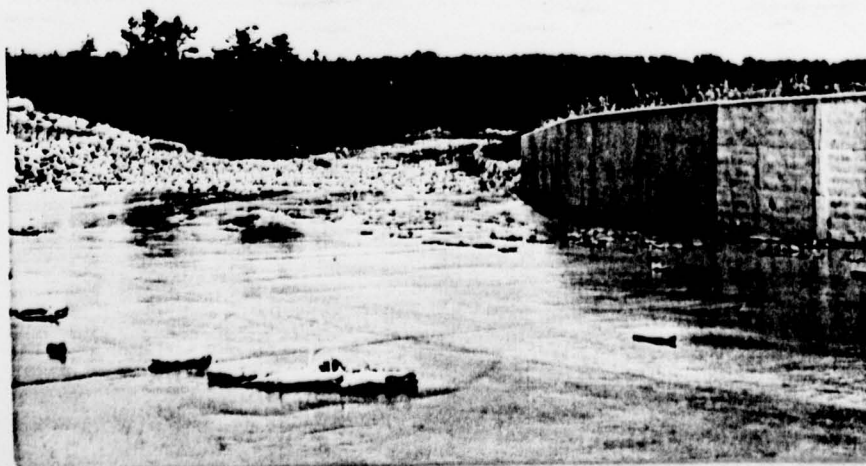
The ogee spillway section was observed to be in good condition. There was no evidence of cracks or other structural distress in the weir, walls or outlet channel slab. Considerable amounts of logs and tree limbs are strewn along the length of the paved channel. One hole was noted behind the left wall of the outlet channel about 100 feet upstream from the downstream end. This hole is about 4 feet from the wall and should be filled. The outlet channel downstream from the paved section is lined with riprap to its terminus at Wolf Run. This lining is in good condition.

Riprapped
Spillway Channel

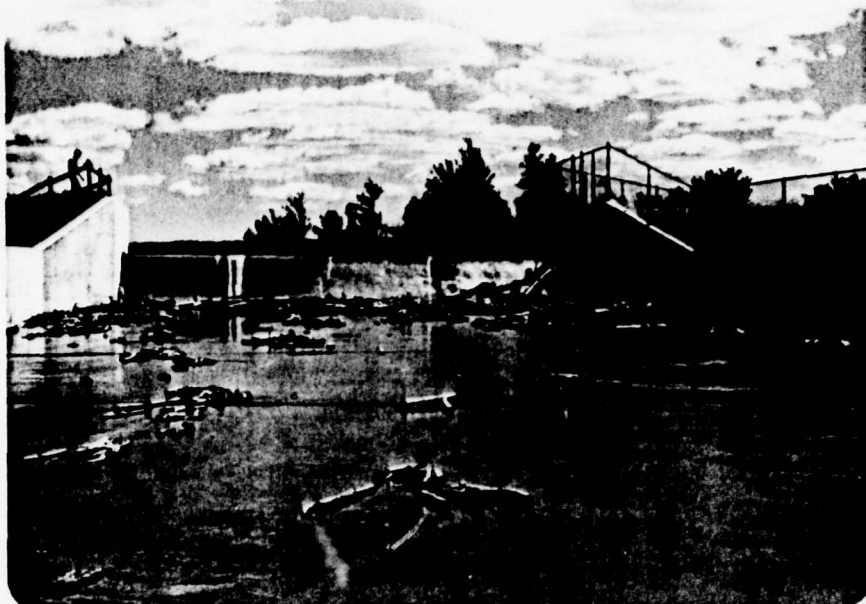
The spillway is a concrete ogee section type weir. There was no evidence of displacement or settlement of this structure. The surface condition is good with no deterioration. This condition applies to the walls, and the spillway outlet channel and walls.

Spillway
Ogee Section
